Palo Verde Nuclear  
Generating Station

**Subject: Palo Verde Nuclear Generating Station (PVNGS) Unit 3  
Docket No. STN 50-530  
License No. NPF-74  
Licensee Event Report 2011-001-00**

**4. TITLE**  
Unit 3 Reactor Trip Due to Failed Open Main Feedwater Pump A Minimum Flow Recirculation Valve

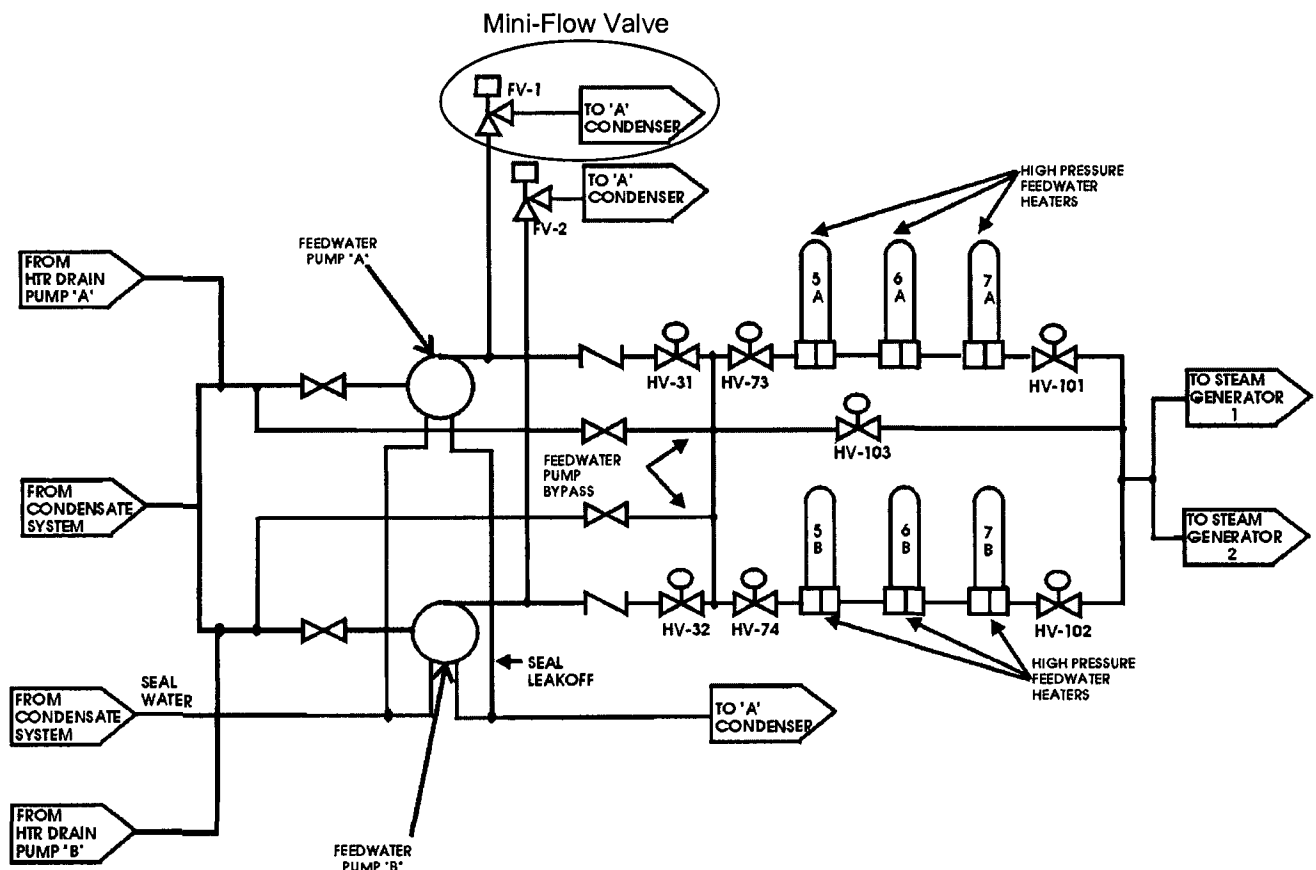
Feedwater Simplified Diagram

The main feedwater system (see diagram) (EIIIS Code: SJ) consists of piping, main feedwater pumps (MFWP) (EIIIS Code: JK), high pressure heaters, valves, controls, instrumentation, and associated equipment which supply feedwater to the steam generators (SG) (EIIIS Code: AB).
